**Final Archaeological Investigations of the Replacements
of Bridges #17 and #18, on New Castle #221
(Beaver Valley Road), New Castle County, Delaware**

FINAL ARCHAEOLOGICAL INVESTIGATIONS
OF THE REPLACEMENTS OF BRIDGES #17 AND #18,
ON NEW CASTLE #221 (BEAVER VALLEY ROAD),
NEW CASTLE COUNTY, DELAWARE

DELDOT PROJECT 83-071-11 DELDOT ARCHAEOLOGY SERIES NO. 62

FHWA FEDERAL AID PROJECT BROS-221(1)

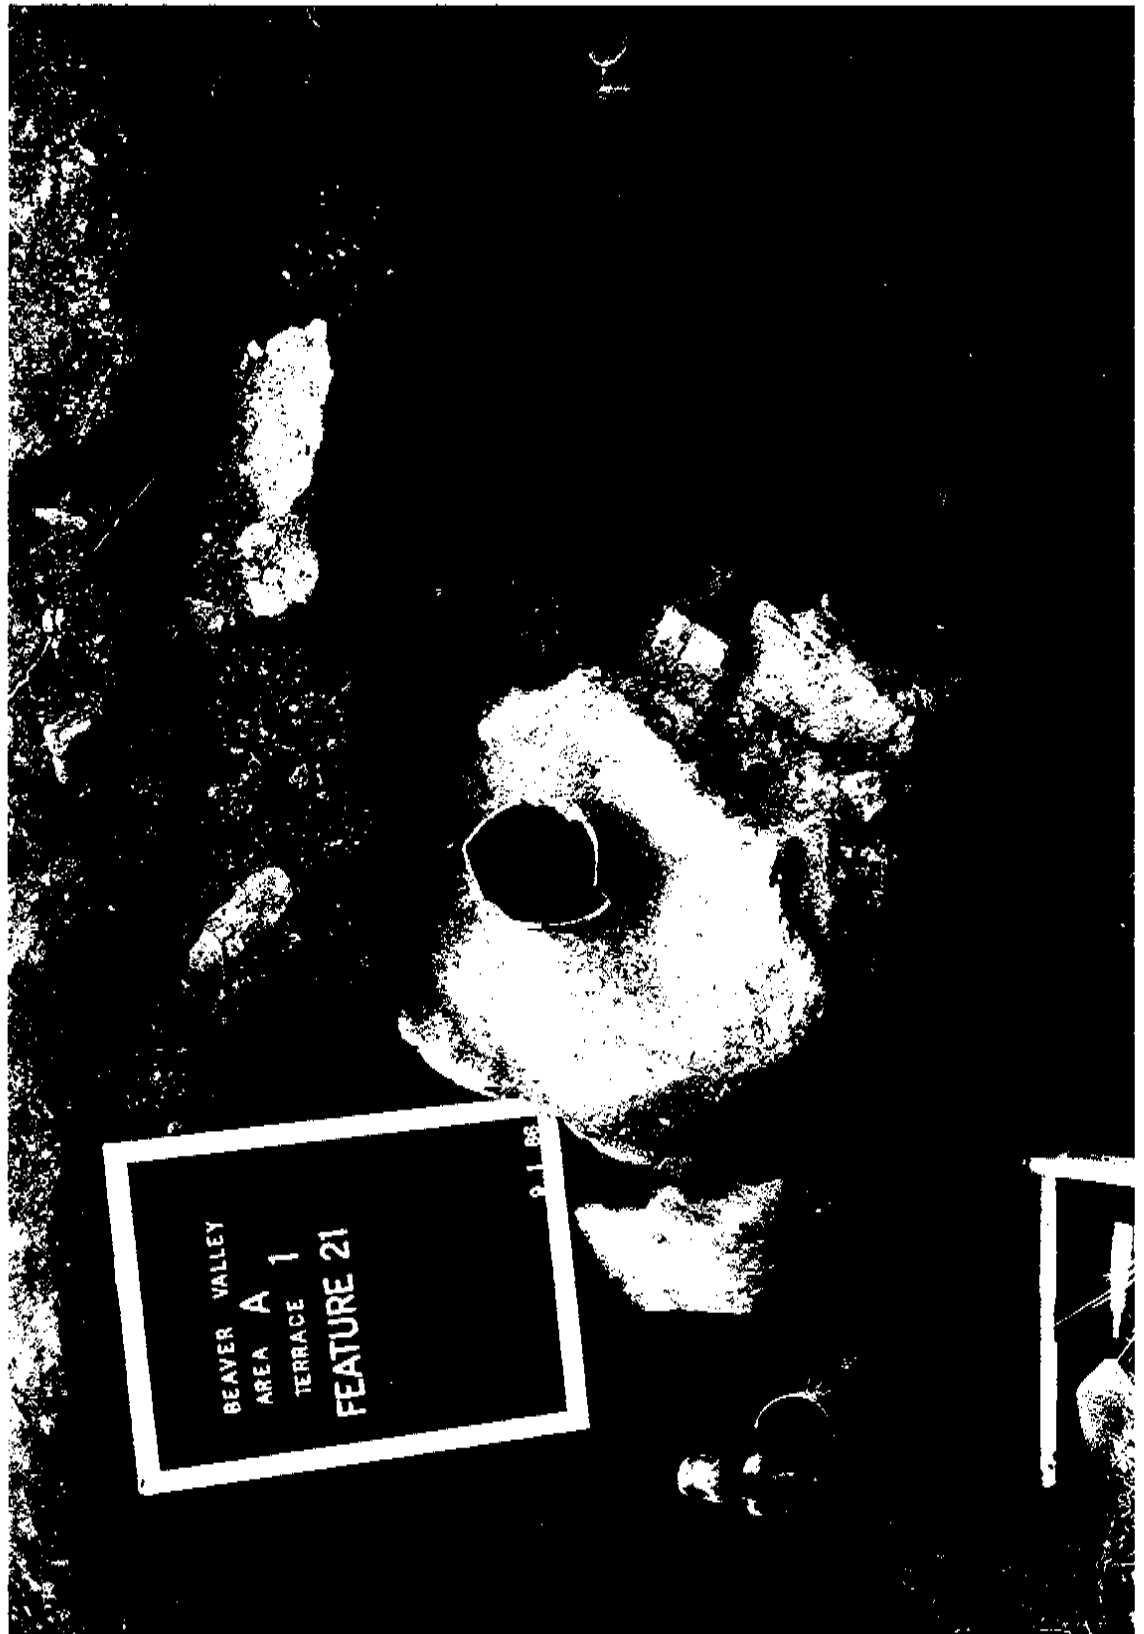
PLATE 16

Feature A-21, Galbreth House
(Component 2, A. Chandler/Galbreth Site)

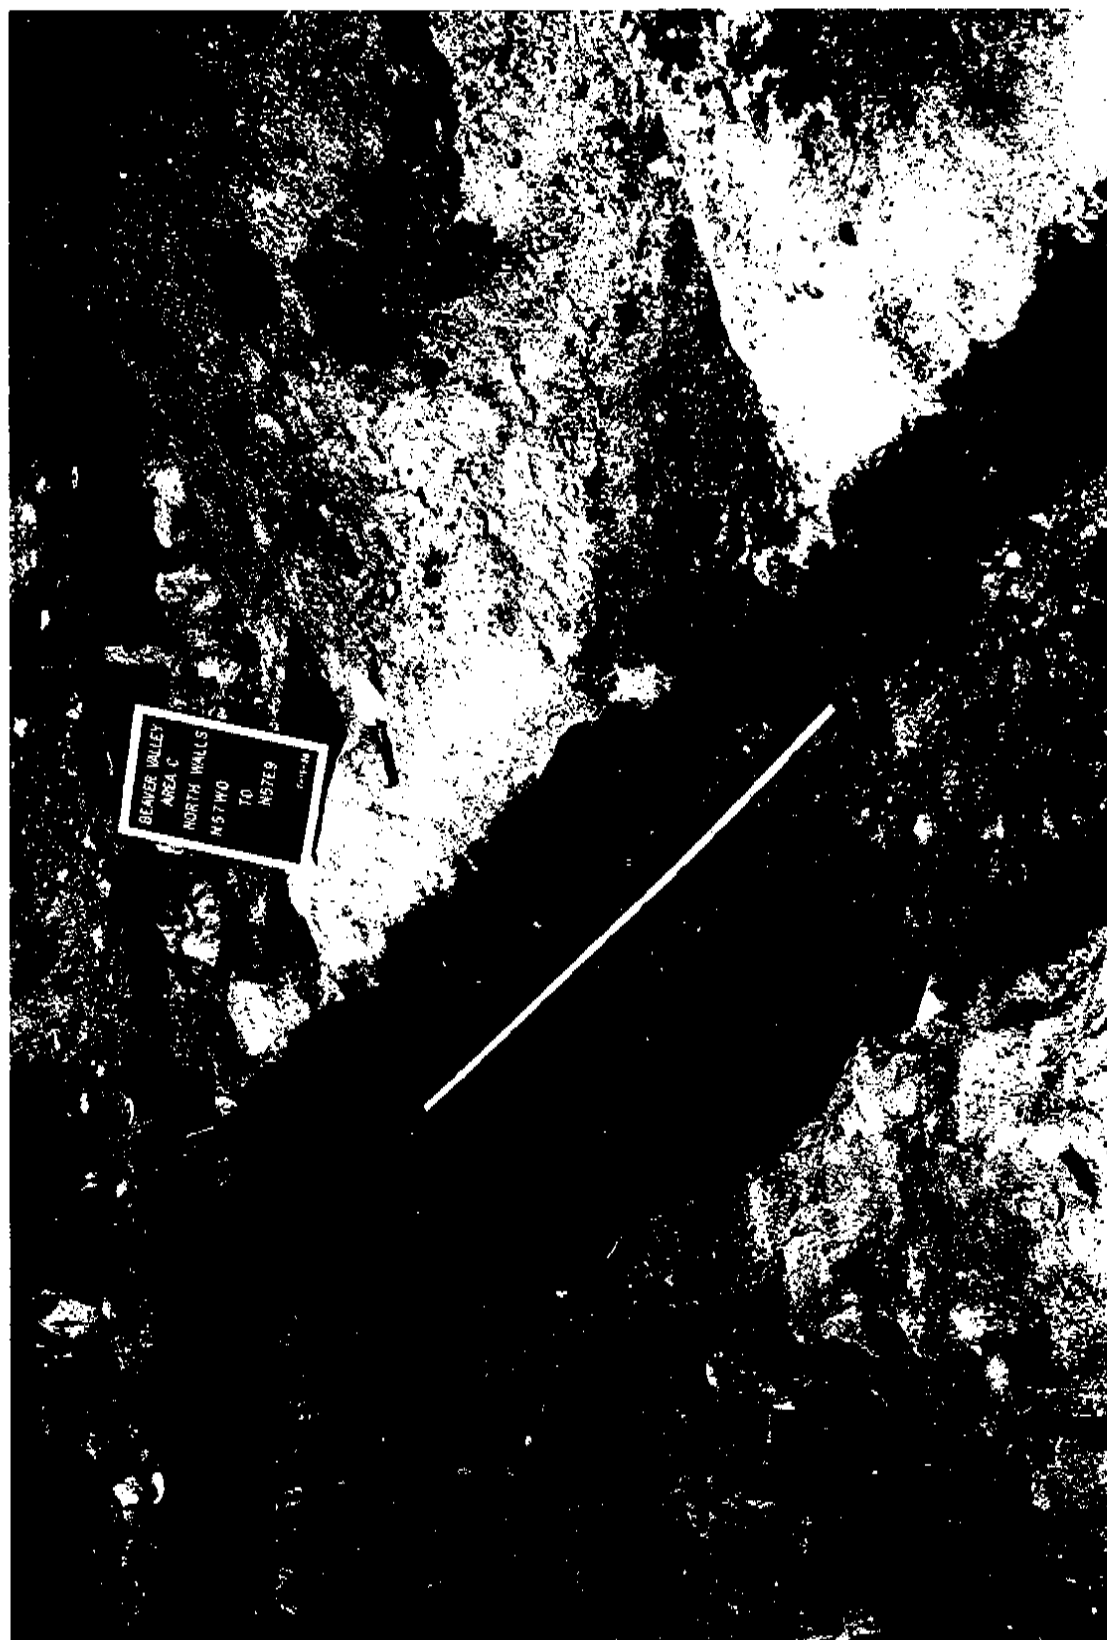
PLATE 18

Profile of the North Wall of Test Units N57 W0 - N57 E9,
J. Chandler/Highfield Blacksmith Shop, (N-569.1, 7NC-B-18)

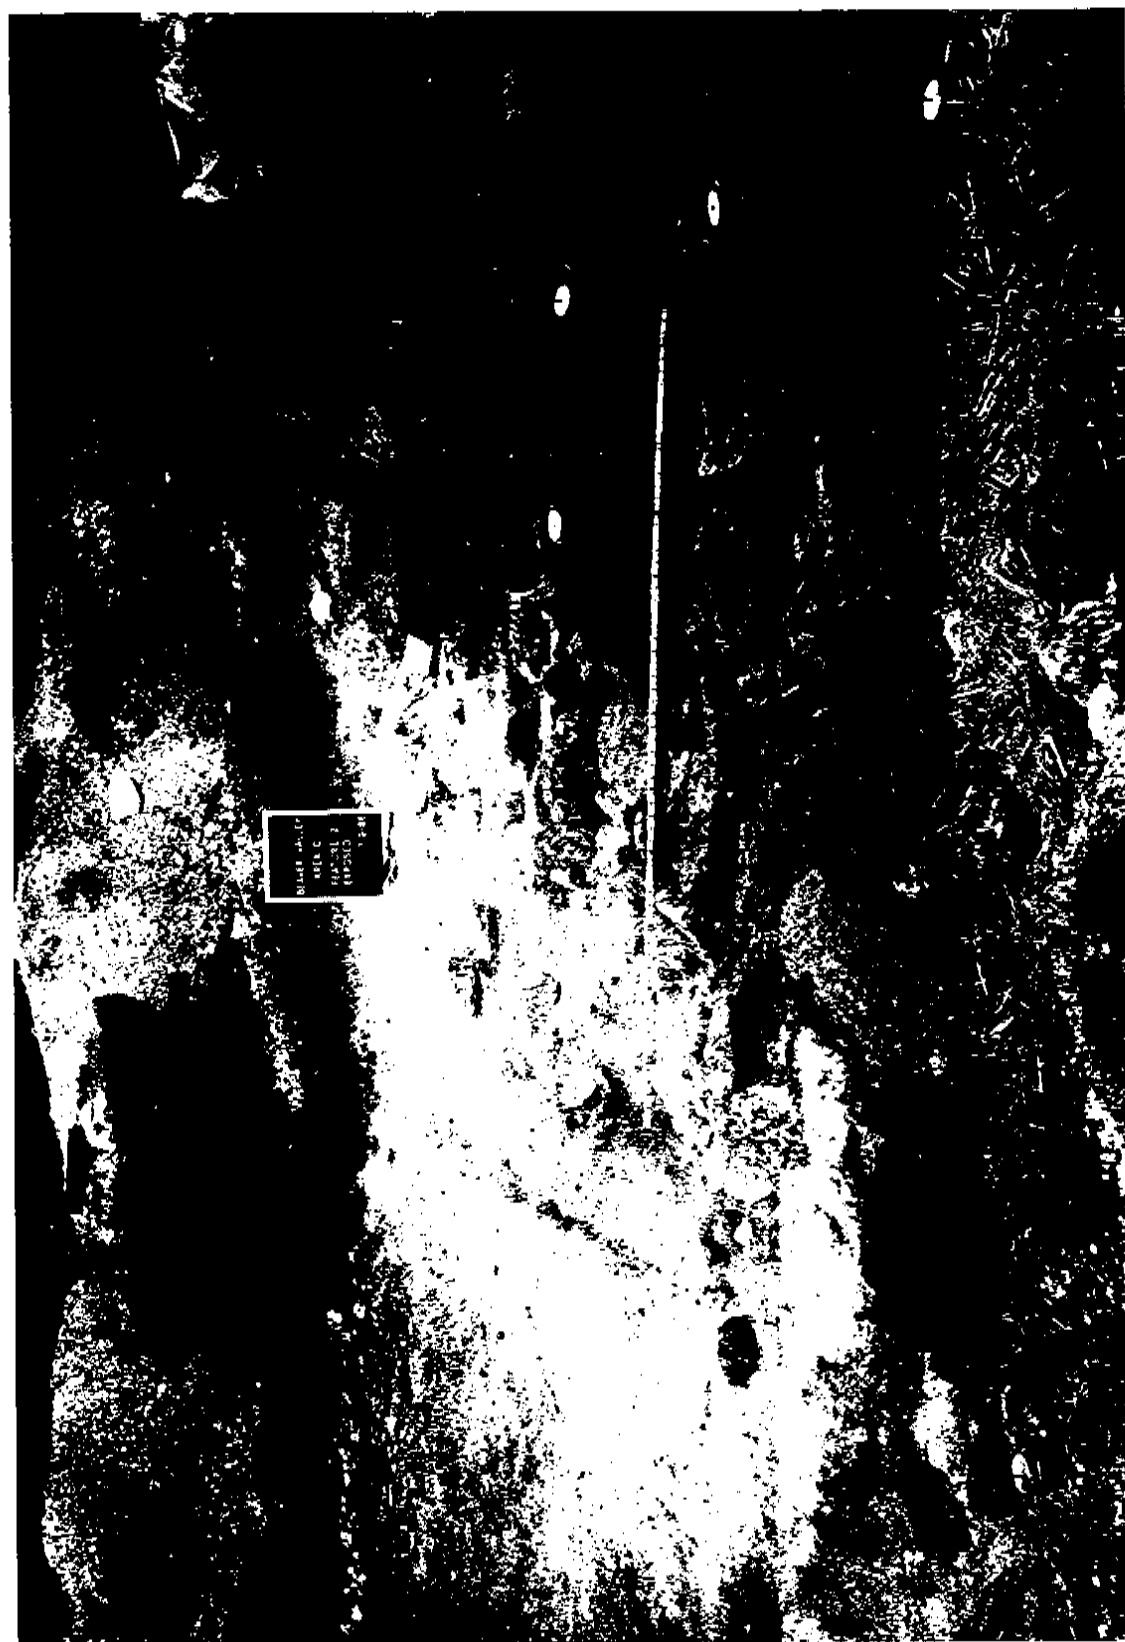
PLATE 19

Micaceous Cap (Feature C-2), Exposed by Phase I and II Excavations,
J. Chandler/Highfield Blacksmith Shop

placed along Beaver Valley Road. The cap was located just below the humus. The humus was only moderately organic and composed primarily of dark brown silt and coal ash and cinders. This micaceous cap appears as Feature C-2 in Plate 19. The cap itself was observed to be 0.3-0.45 feet thick and from approximately 0.25-0.70 feet below surface. Part of the cap was screened, and found to contain very few historic artifacts. Indeed, the only historic artifacts recovered from the micaceous cap in any of the Phase I or II excavations were a few small, heavily damaged and relatively non-diagnostic whiteware, window glass and wire nail fragments.

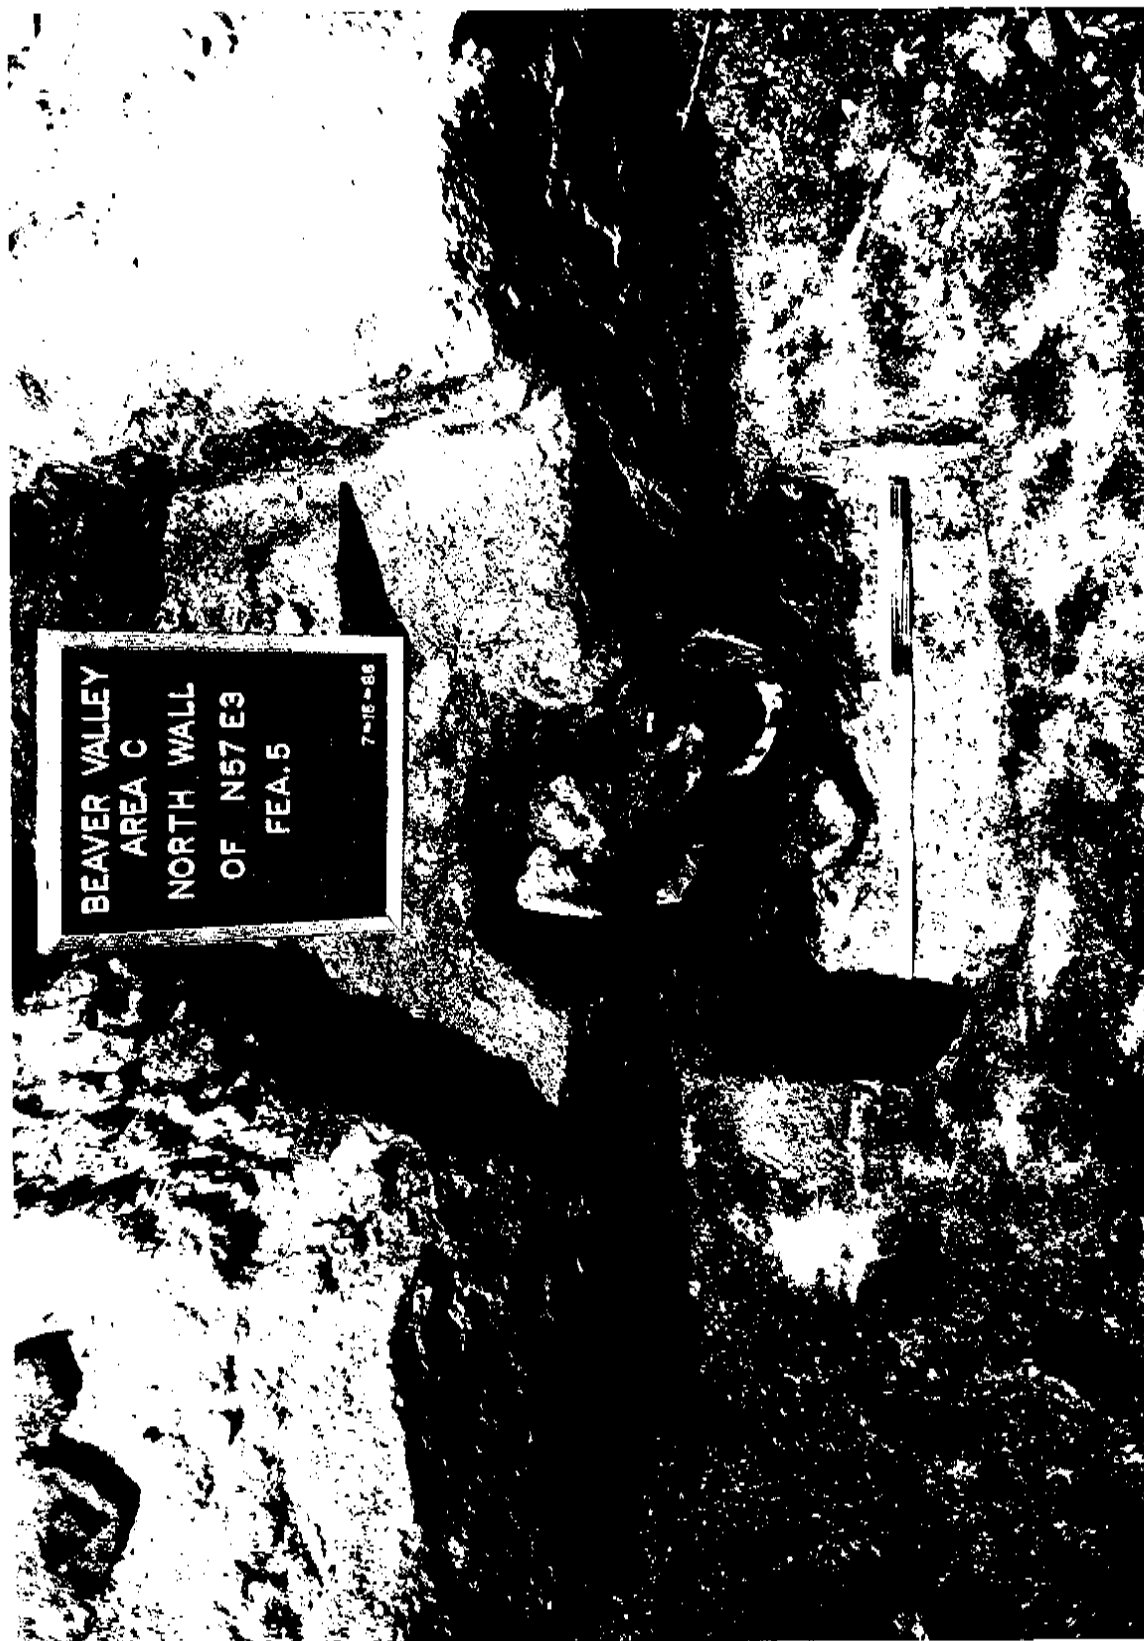
PLATE 20

Profile of Feature C-5, Test Unit N57 E3,
J. Chandler/Highfield Blacksmith Shop

One feature was located in test units N57W3-N57E9. This feature, a large postmold was first located while trowelling the surface of Level IV in Test Unit N57E3 and was labelled Feature C-5. A profile of this feature appears in Figure 63. Feature C-5 also appears in Plate 20. Besides the micaceous cap and disturbed stone and mortar foundation to the south, this was the only other feature located in the J. Chandler/Highfield site. Upon excavation of the entire trench, Feature C-5 was observed to penetrate the two strata (Levels V and VI) beneath Level IV (Figure 63). Also associated with Feature C-5 were two thin horizons of dark gray-black coal ash on either side of the feature (Figure 63). These lenses were similar in charcoal content to the homogeneous very dark brown silt feature fill found within Feature C-5.
